SATURN S-IB STAGE FINAL STATIC TEST REPORT

SATURN S-1B STAGE
FINAL STATIC TEST REPORT
STAGE S-1B-1

JUNE 4, 1965

SYSTEMS STATIC TEST BRANCH

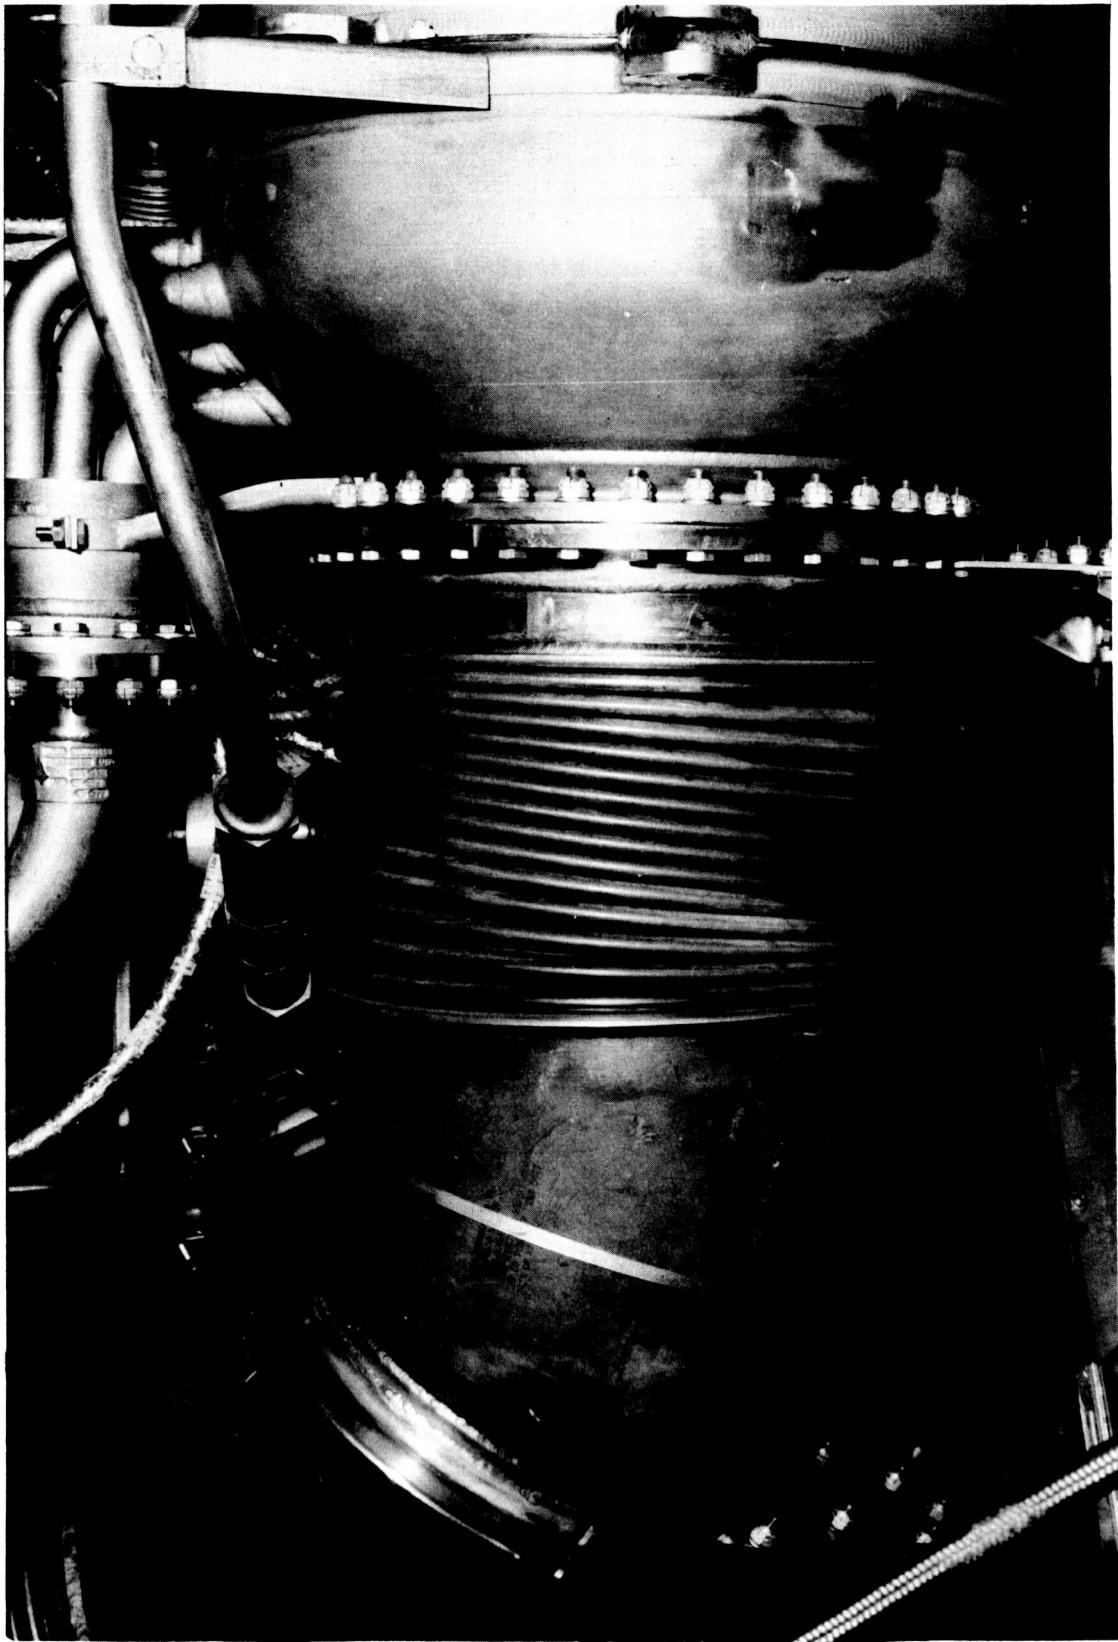
FIGURE 2-3. DISTORTED BELLOWS IN TURBINE EXHAUST DUCT, HEAT EXCHANGER INLET ENGINE 8

Visual inspection of engine 8 after test SA-26 revealed a distorted bellows section in the turbine exhaust duct adjacent to the heat exchanger. The bellows section will be replaced during post static checkout of the stage at Michoud.

2. Visual inspection of engine 8 after test SA-26 revealed a distorted bellows section in the turbine exhaust duct adjacent to the heat exchanger inlet (see FIGURE 2-3). The extent of damage will be investigated further during post static checkout at Michoud.

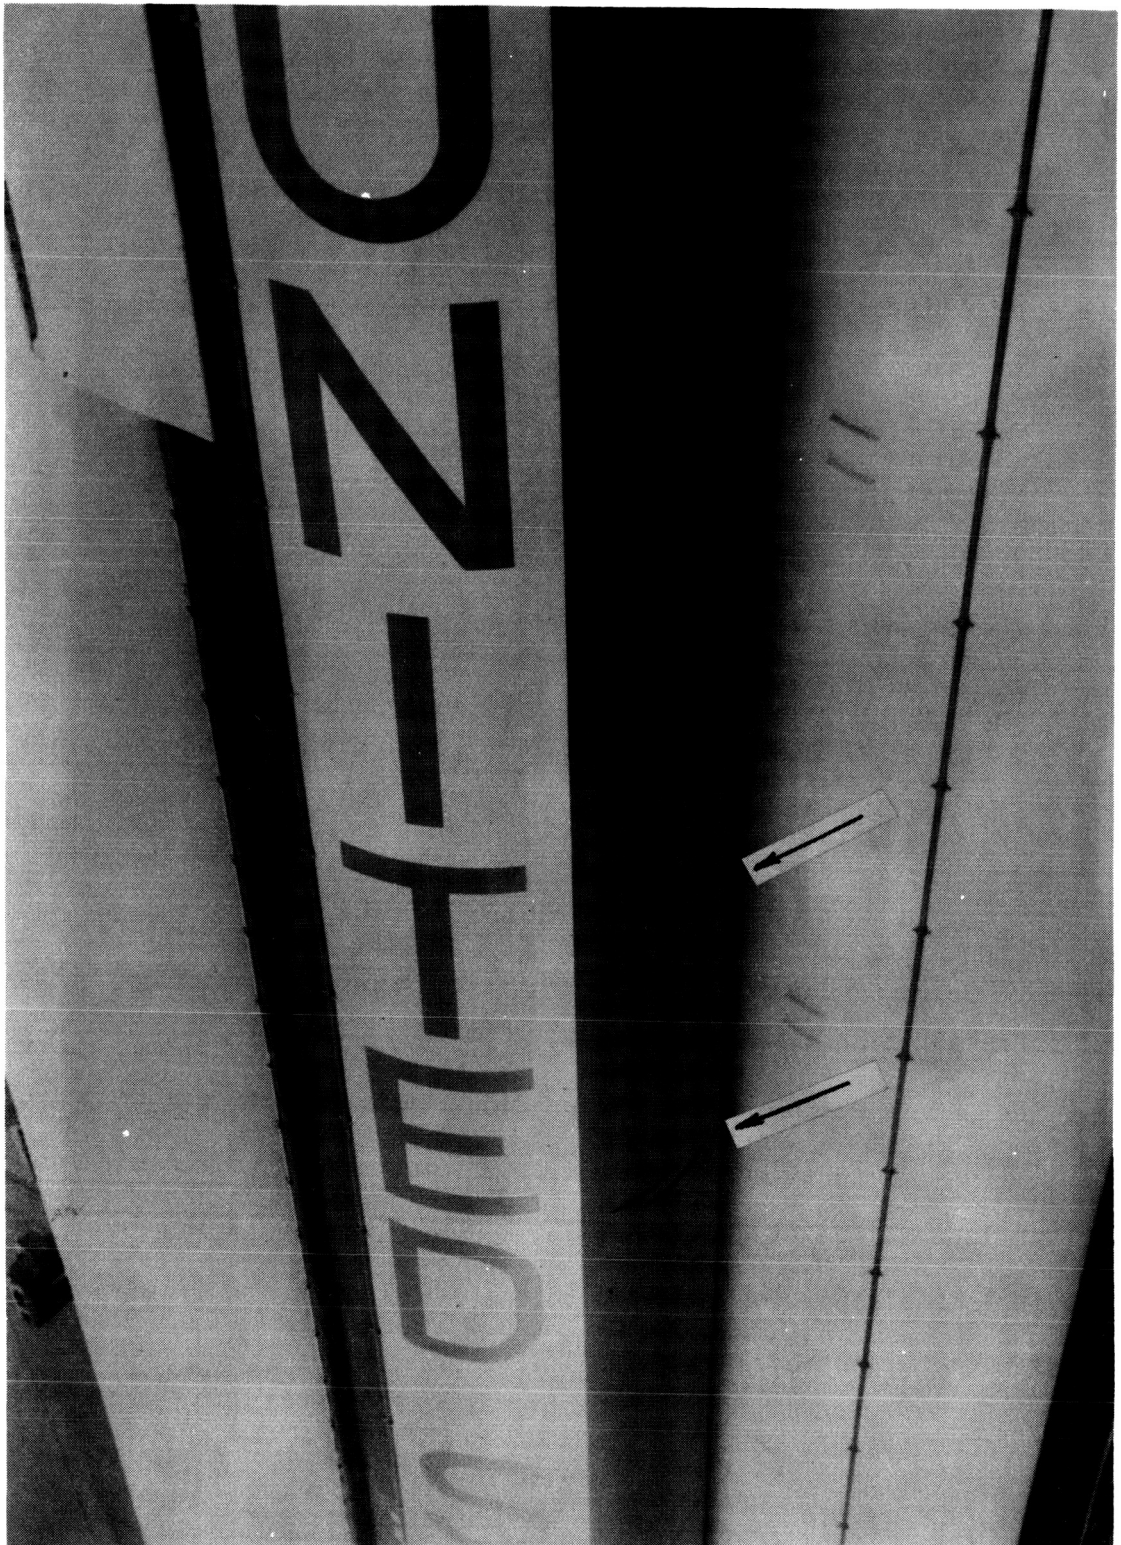
FIGURE 4-5. RIPPLES IN TANK F-3
(Photograph Touched Up)

During stage removal from the static test tower, five ripples in fuel tank F-3 were observed. The ripples were approximately 12 inches long and 1/4 inch deep.

During stage removal from the static test tower, five ripples were noted in fuel tank F-3. The ripples were approximately 12 inches long and 1/4 inch deep (see FIGURE 4-5). The cause of the ripples is under investigation (reference UCR 01186). Further investigation will be conducted on stage S-IB-2 during installation and removal of this stage from the static test tower. An instrumentation program is being formulated for this investigation.

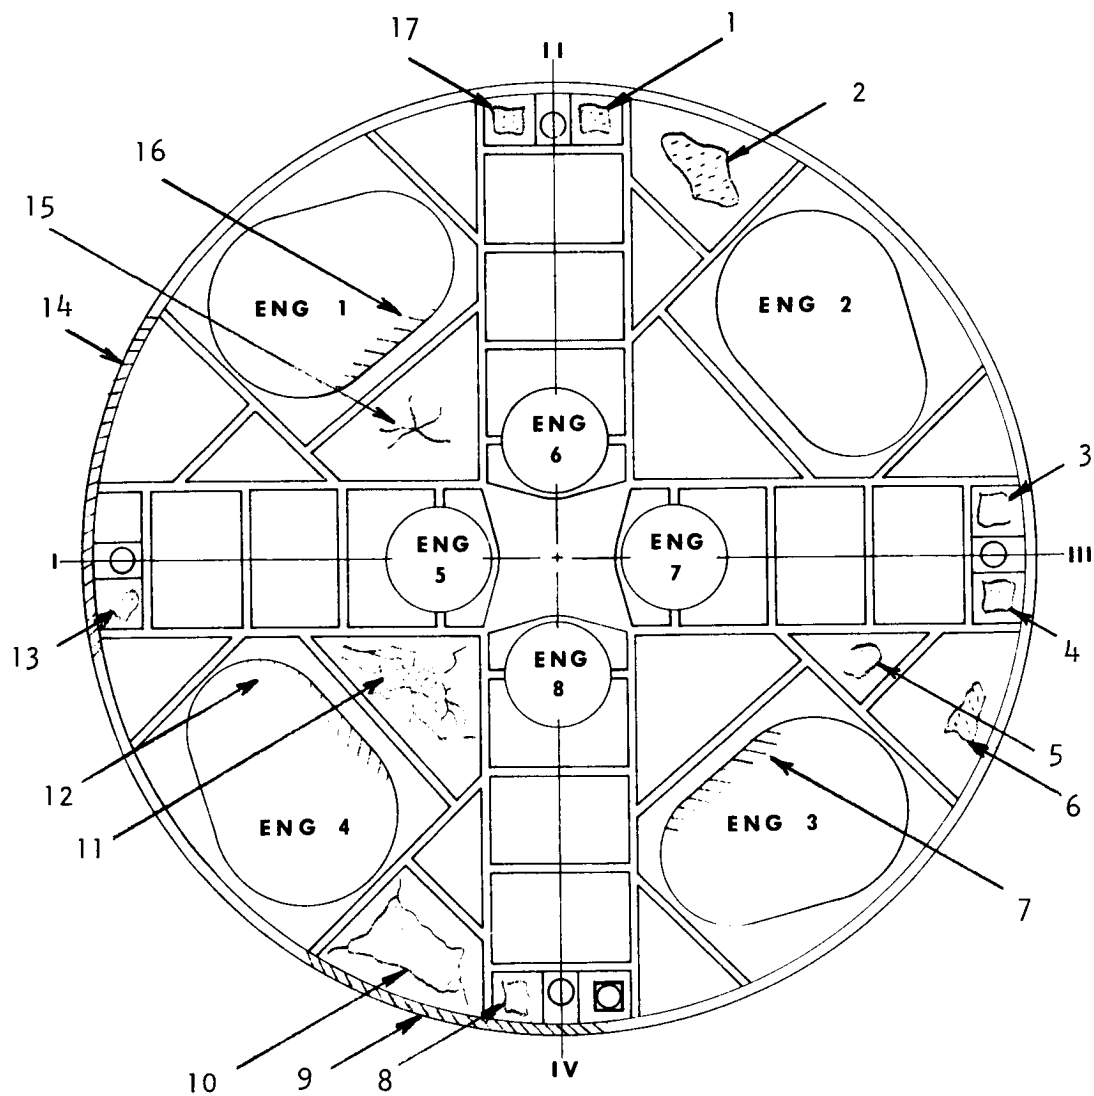
Post test inspection of the heat shield panels following test SA-26 revealed that the usual damage was incurred during this test. Approximately 1,500 square inches of M-31 insulation material separated from the panels. Part of the remaining M-31 insulation was cracked and loose. The post test status of the heat shield panels is shown in FIGURE 5-1 and TABLE 5-1.
